Picture Report

101 Sample St.
Winnipeg Mb.

Prepared for: Sample Report (Homowner/Insurance Co/Property Management Co)

Prepared by: Emond Siding & Roofing Co., Inc
Leo Emond

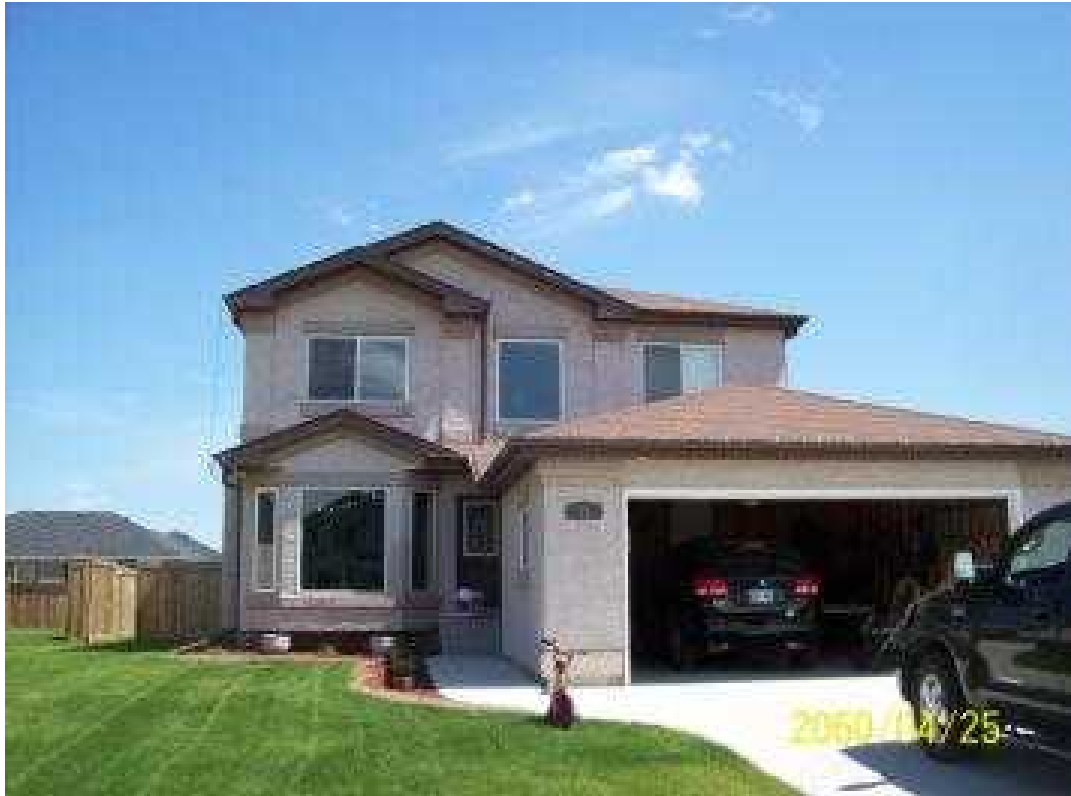
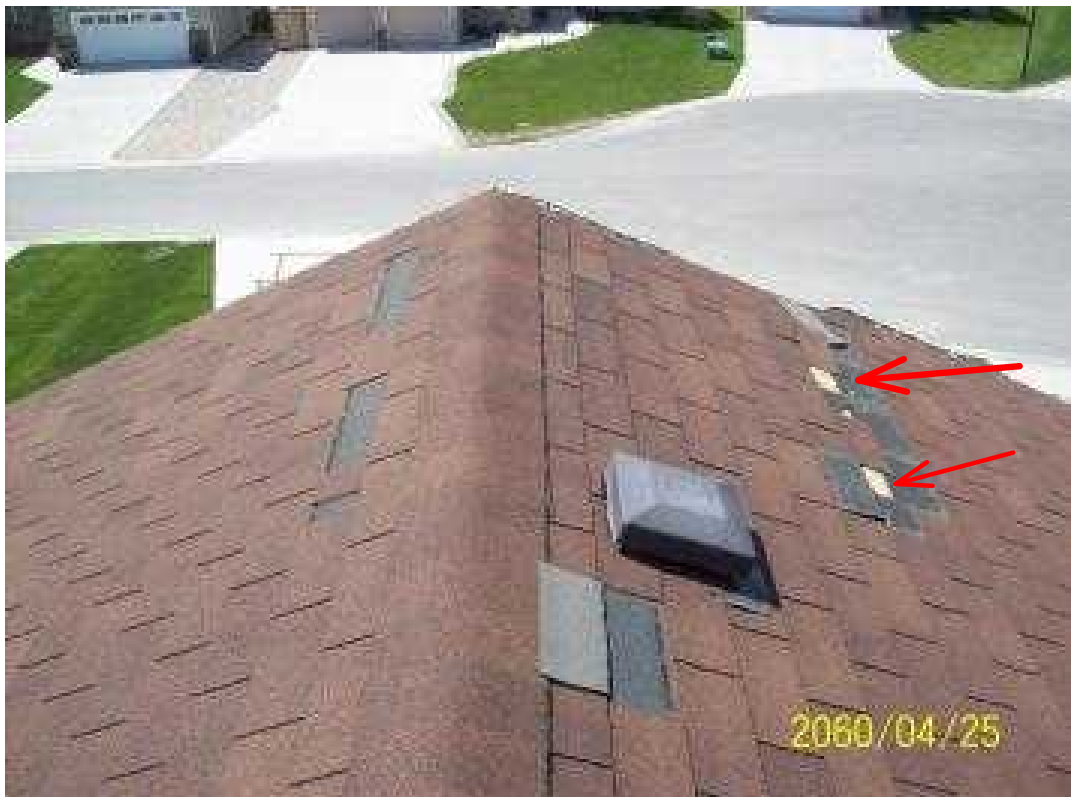
Windblown Shingles. Exposed plywood.

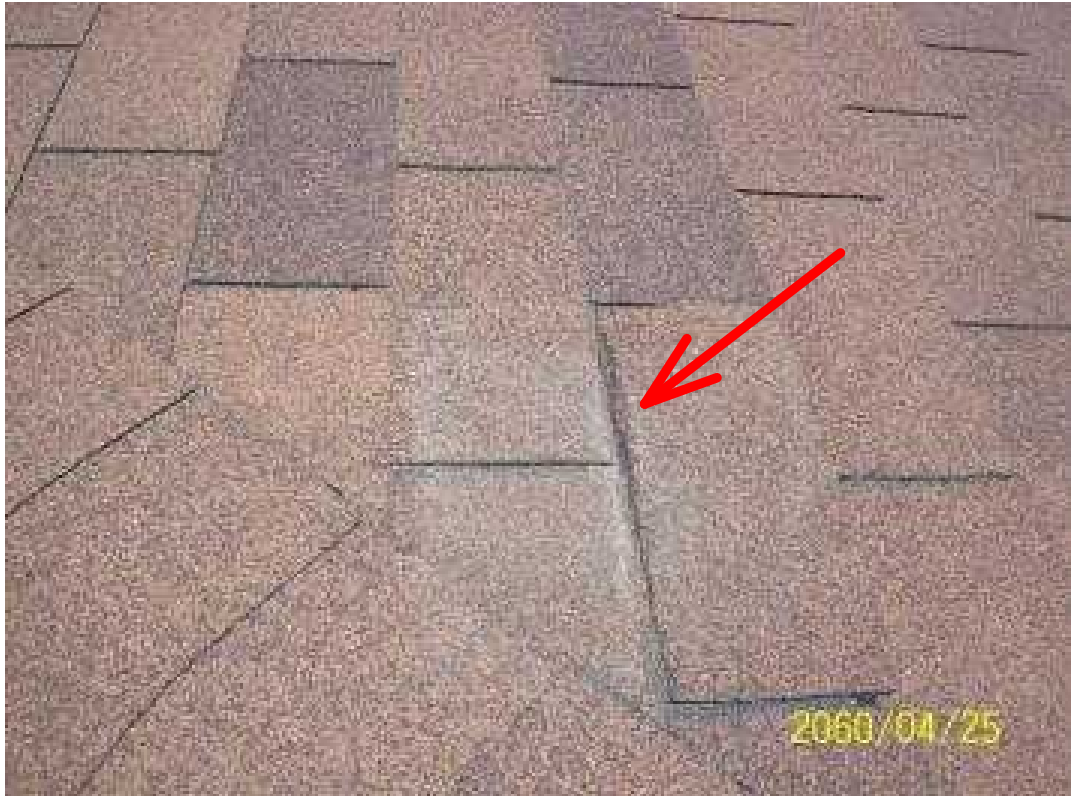
Fractured top of Tab.

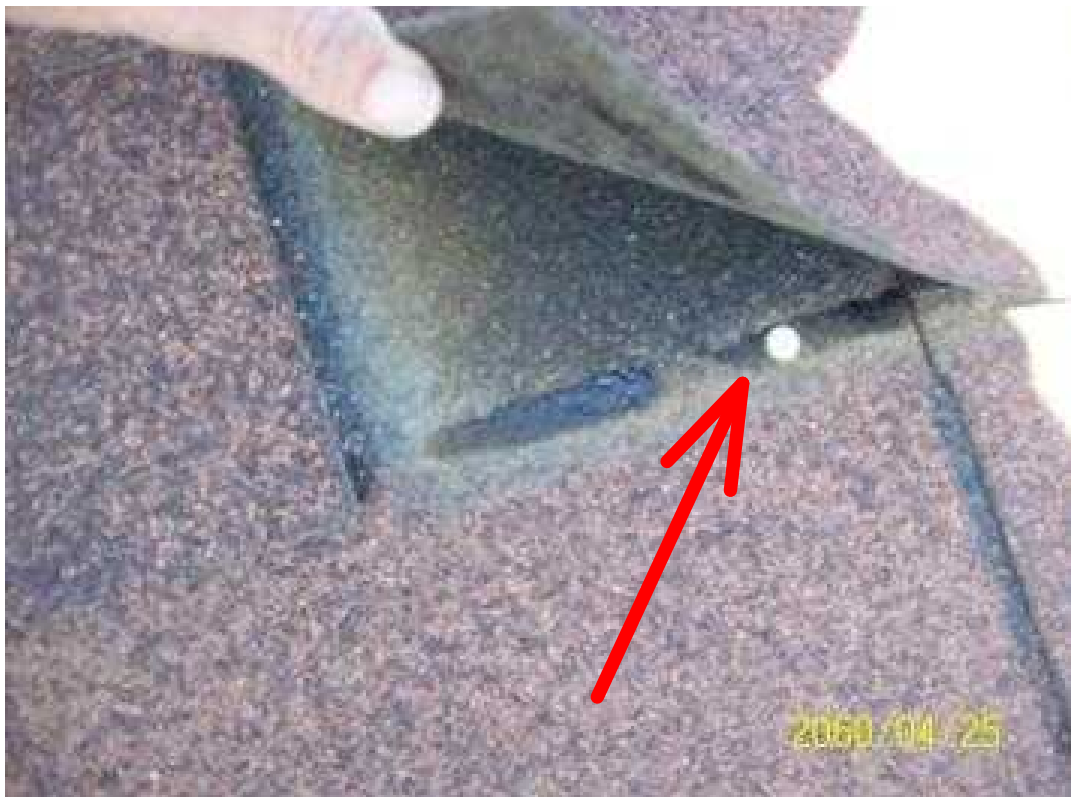
Contaminated Self sealing strip with dust.

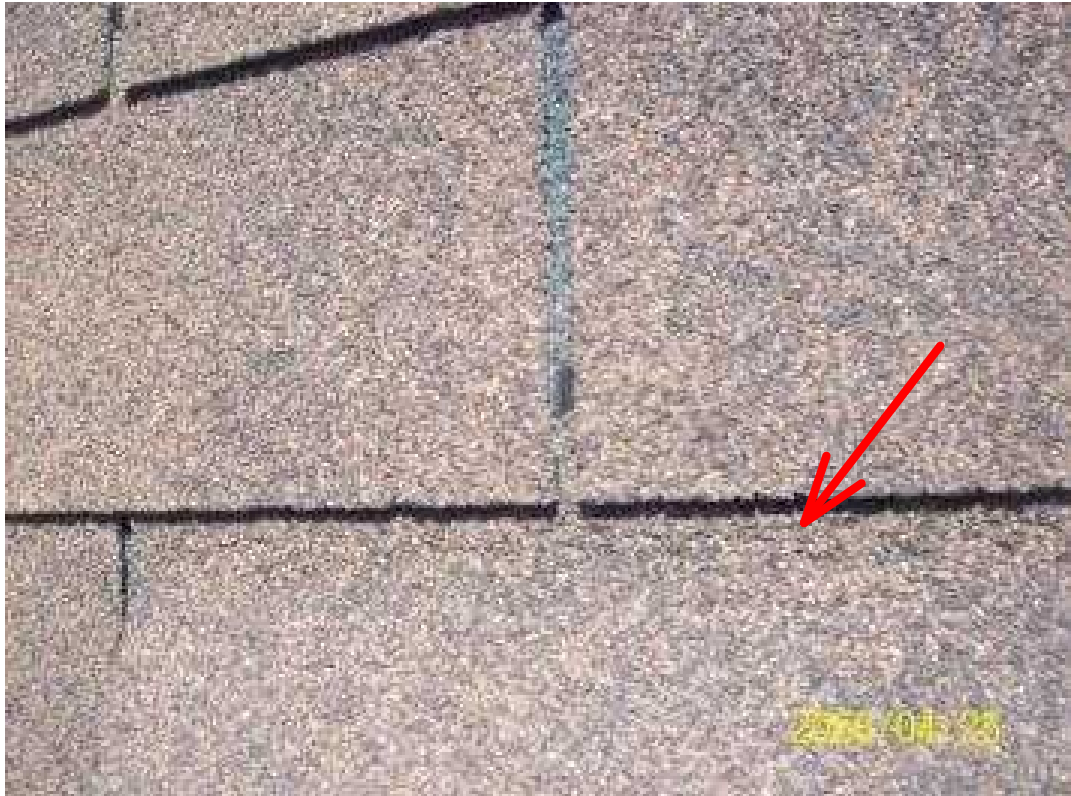
Fracture of the top of shingle tab. Due to wind lifting tab.

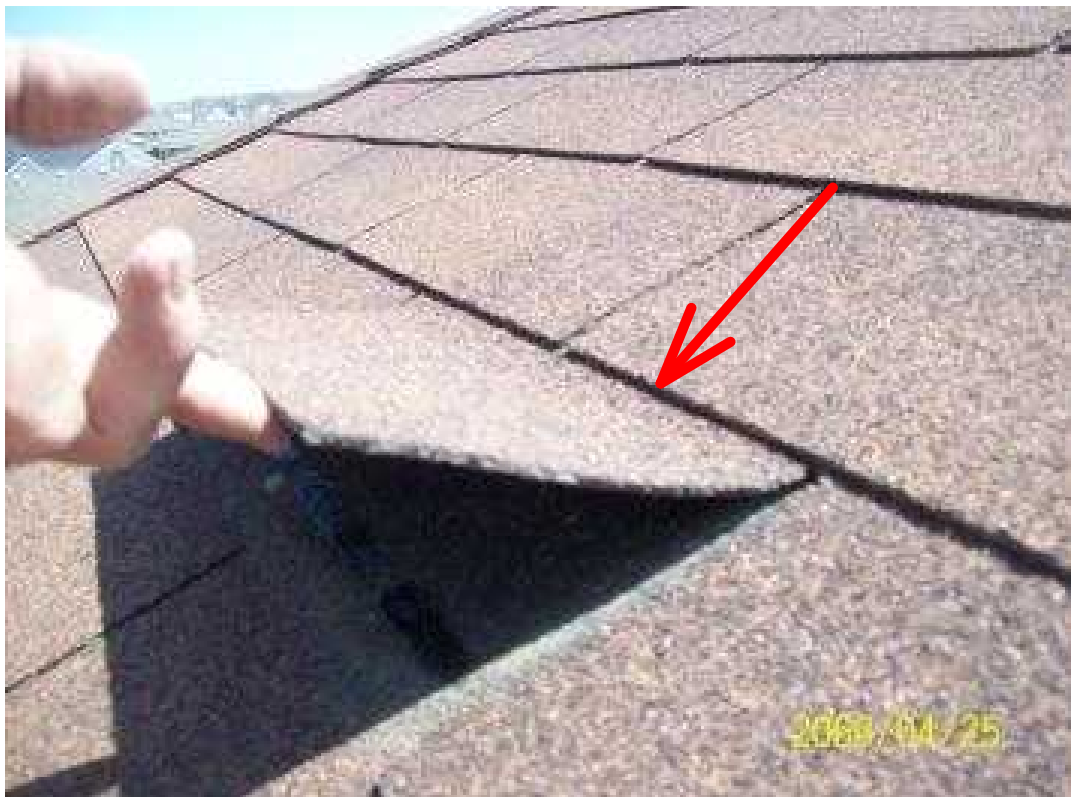
Example of the continouse effect of wind lifting tab,causing fracture.

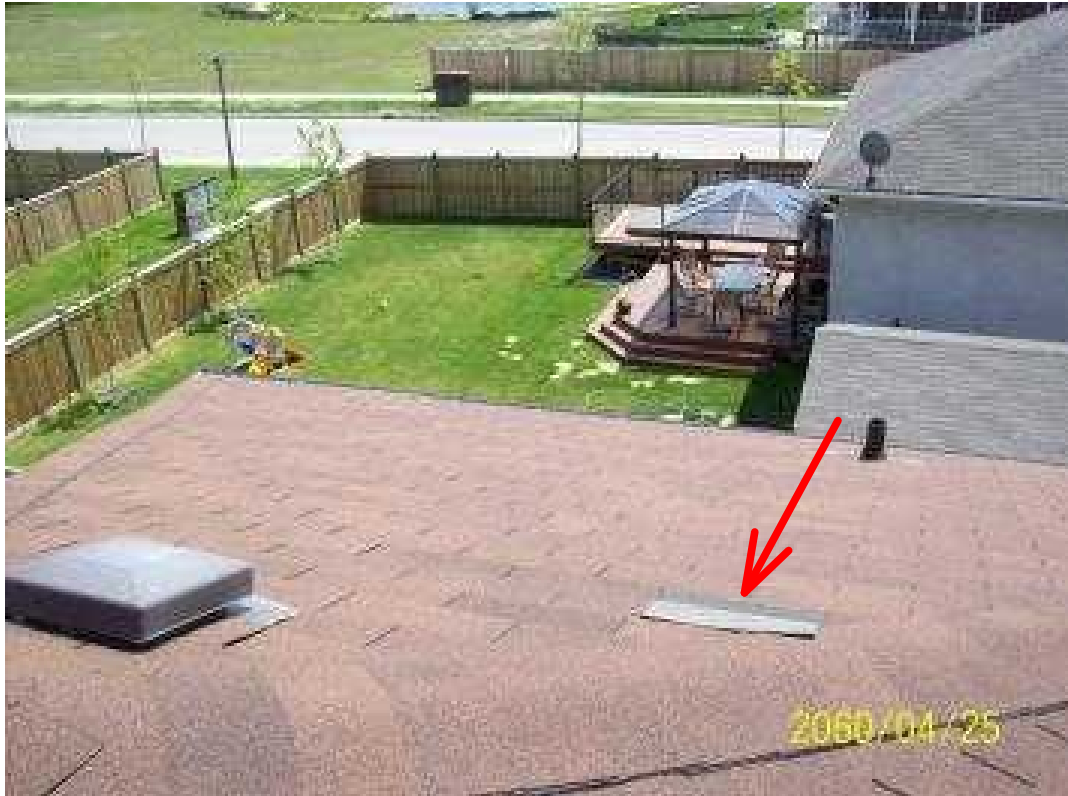
Wind blown shingle.

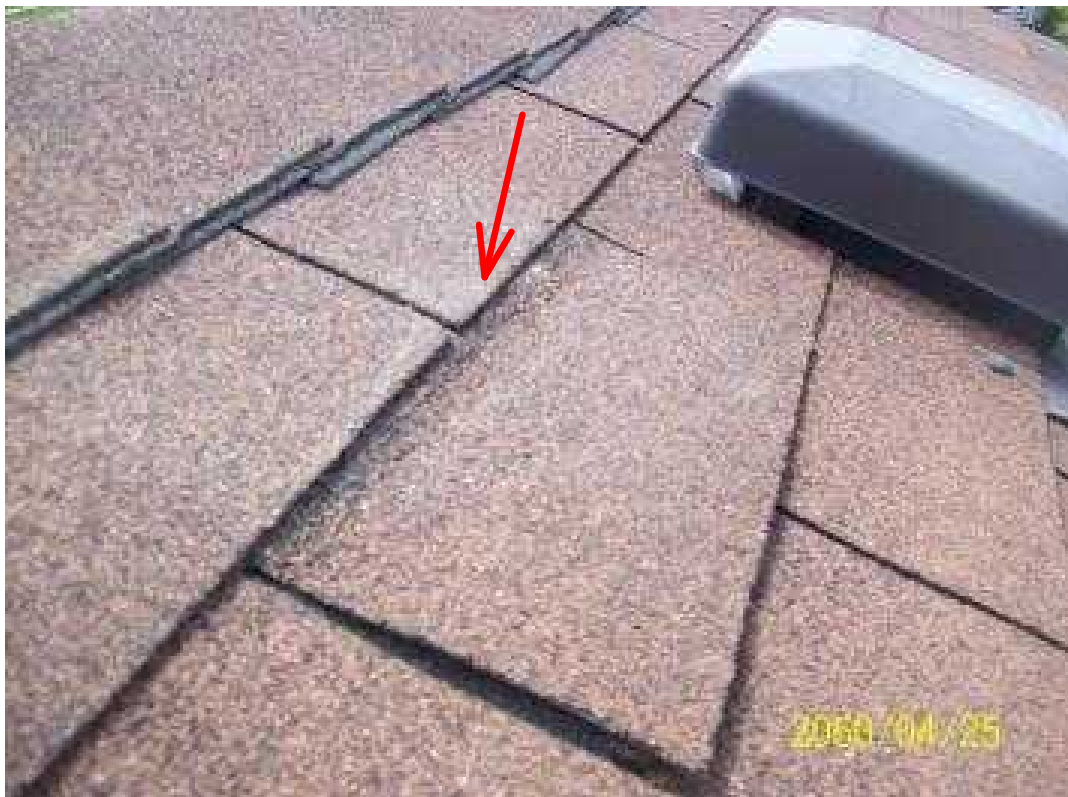
Damage to all slopes

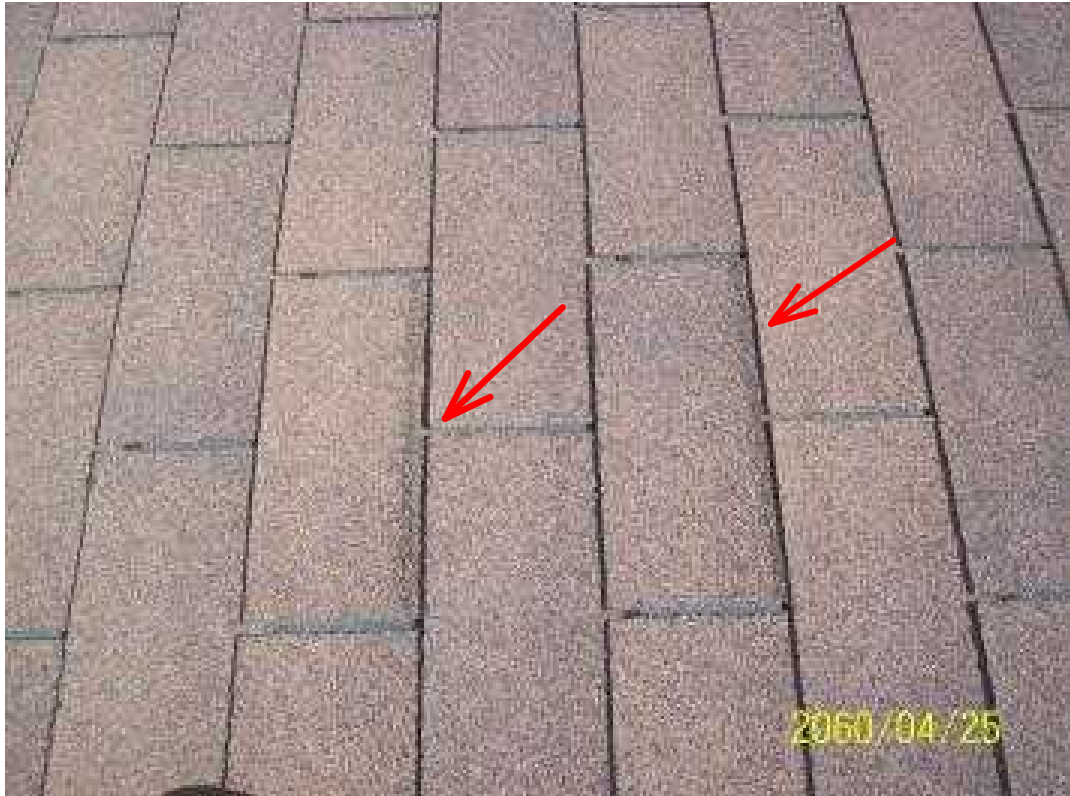
North Slope Fractures

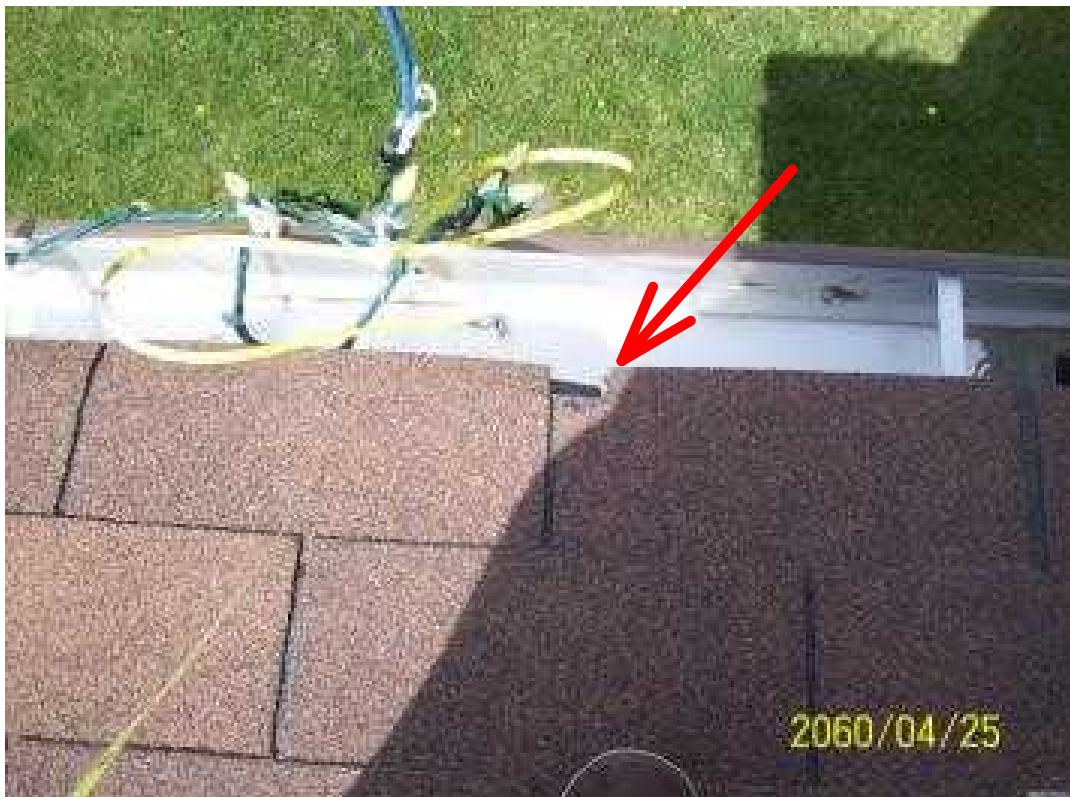
Hail hit to shingle

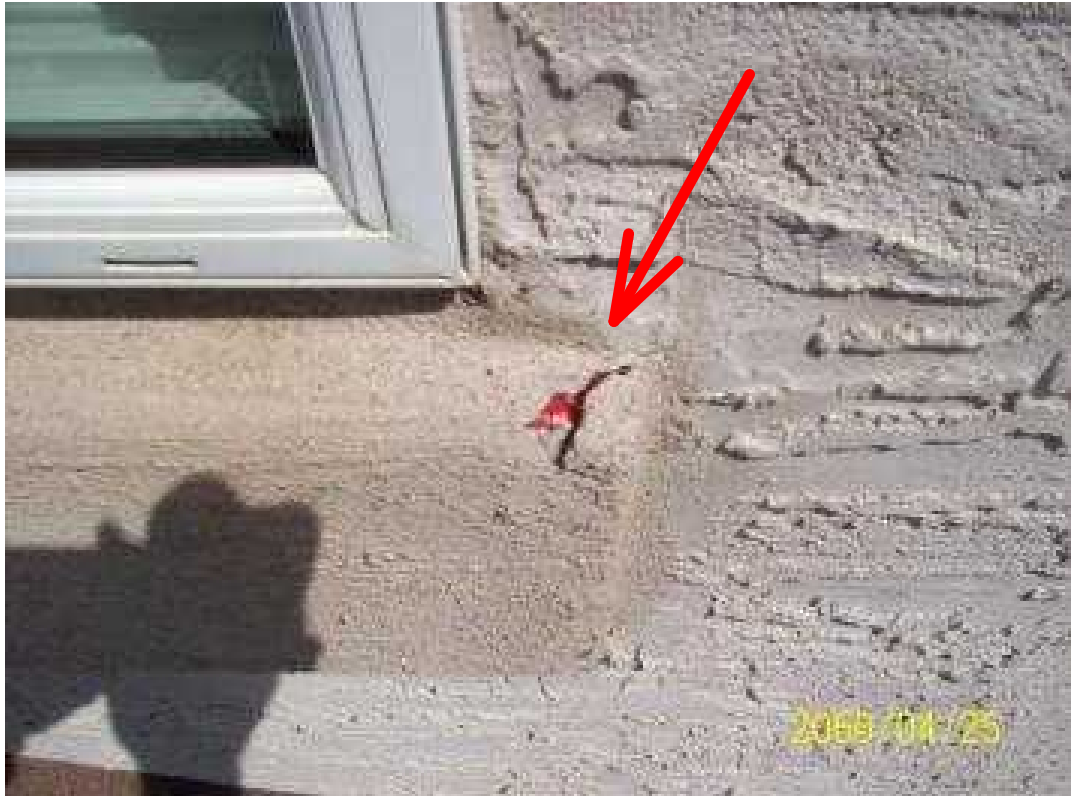
Damage to stucco

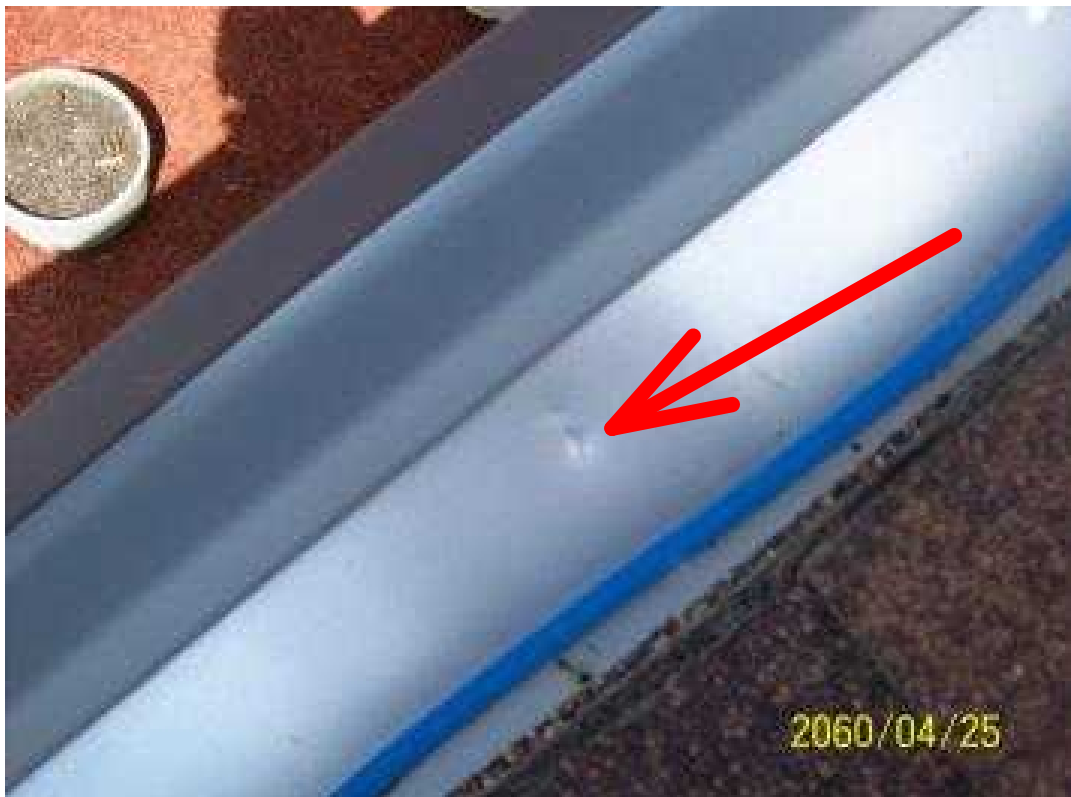
Hits to aluminum eaves troughs
